Report No. FAA-AAS-80-1

## NATIONAL RUNWAY FRICTION MEASUREMENT PROGRAM

E. A. Hickok and Associates, Inc.

FINAL REPORT

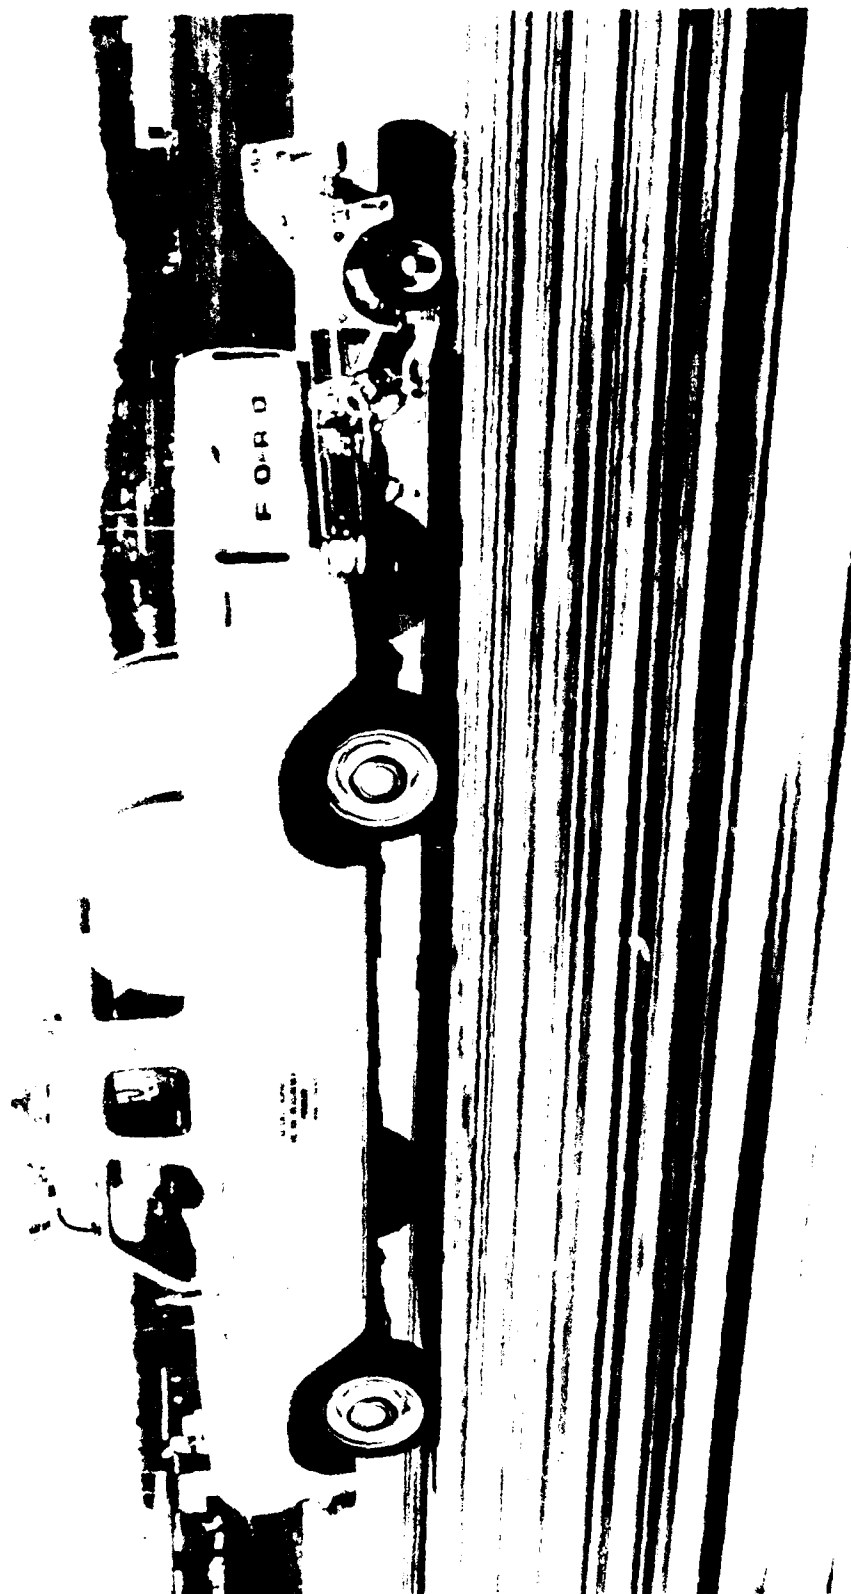
FIGURE 1. WET FRICTION TEST

A Mu-Meter with a MK 3 recorder was the device used for measuring pavement side-force friction. Attached to the triangular frame were two side wheels, which measured friction, and one back wheel, which measured distance and drove the strip chart. A close-up of the Mu-Meter is shown in Figure 2.

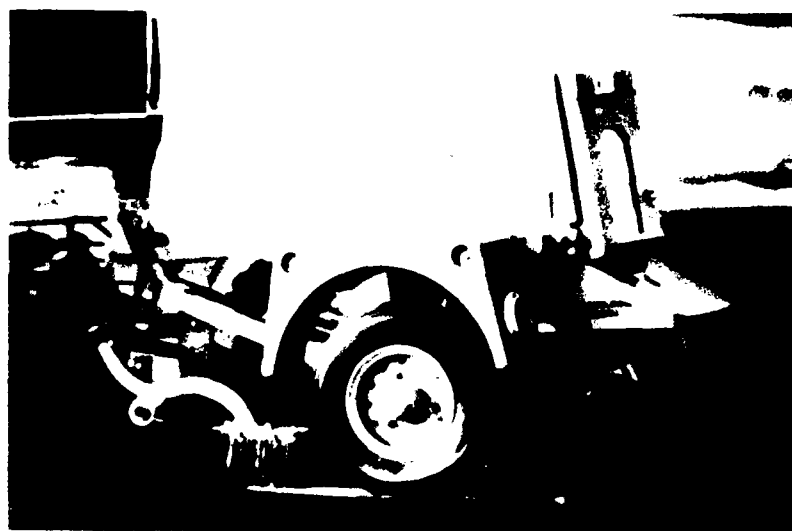
FIGURE 2. MU-METER

When in test position, the two friction measuring wheels were set at a nominal included angle of 15 degrees ( $7\frac{1}{2}$  degrees each wheel). The Mu-Meter measured the side slip force on these two wheels, which is directly proportional to the friction between the measuring tires and the pavement surface. The Mu-Meter measures the force perpendicular to the direction of travel and is therefore insensitive to variations in bearing friction and rolling resistance. Because it is towed, it will self-align and equalize the forces on both wheels. The Mu-Meter was equipped with a self-watering system, which distributed a controlled water depth of 1.0 mm (0.04 in.) in front of each friction measuring wheel.

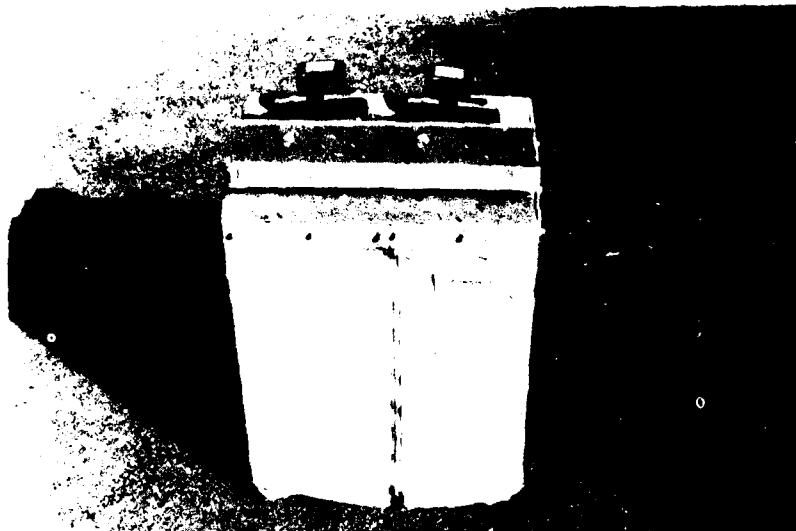
FIGURE 6. STEREO CAMERA FIXTURE

Photographs of the pavement surface were taken with two 35 mm cameras. They were mounted on a metal frame at an angle so that the photographs could be viewed with a stereoscope. Electronic flashes were used as a light source. Figure 6 shows the stereo camera fixture.

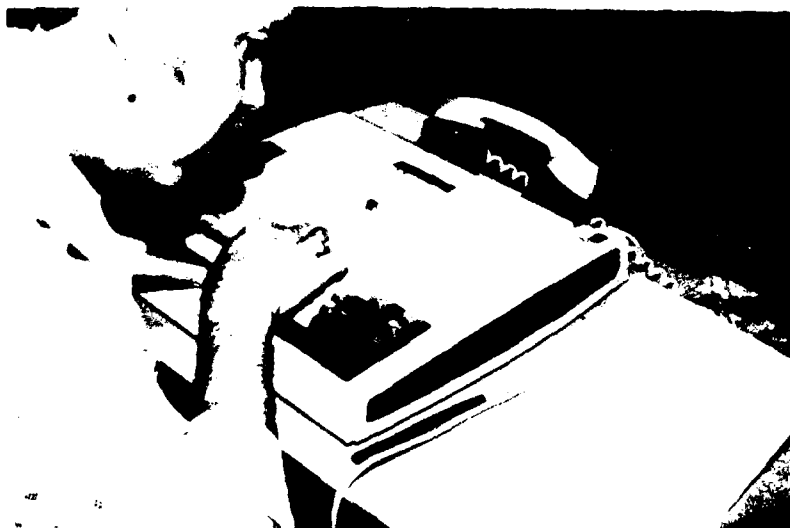
FIGURE 7. PORTABLE COMPUTER TERMINAL

A portable terminal, which could access the computer through any common telephone, was used by the survey team to transmit and receive data and messages. Figure 7 shows the portable terminal in use by a survey team member. Two-wheel travel trailers were used as field offices and security storage space. A trailer is shown in Figure 8.
